Service Precautions

Supplemental Restraint System (SRS)

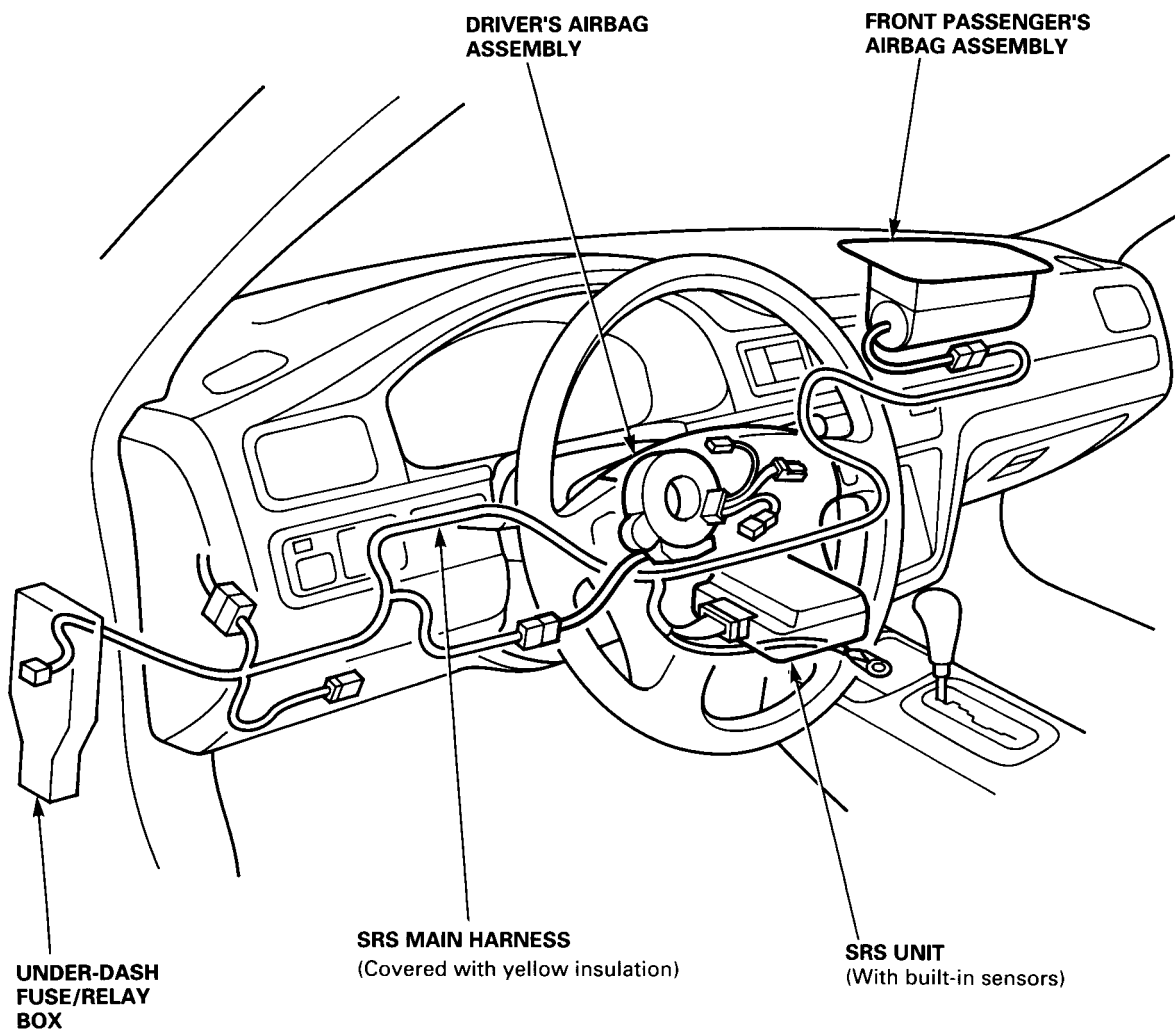
The Acura 2.5TL/3.2TL SRS includes a driver's airbag, located in the steering wheel hub, and a front passenger's airbag located in the dashboard above the glove box. The SRS unit is not part of the airbag assembly and has built-in sensors (SRS-Type III).

- ① SRS unit (including safing sensor and impact sensor) is located under the dashboard. Avoid strong impact with a hammer or other tools when repairing the front side frame and the lower part of the dashboard. Do not apply heat to these areas with a torch, etc.

- ② All SRS electrical wiring harnesses are located under the lower part of the dashboard below the dashboard panel. (All SRS electrical wiring harnesses are covered with yellow insulation.) Care should be taken not to damage the harness when repairing this area.

- ③ Do not apply heat of more than 100°C (212°F) when drying painted surfaces anywhere around the locations of SRS components.
- ④ If strong impact or high temperature needs to be applied to the areas around the locations of SRS components, remove the components before performing repair work.

- ⑤ If any of the SRS related components are damaged or deformed, be sure to replace them.
