Troubleshooting Flow Chart — TW Sensor

PGM-CARB Control System [KX, KS, KZ]

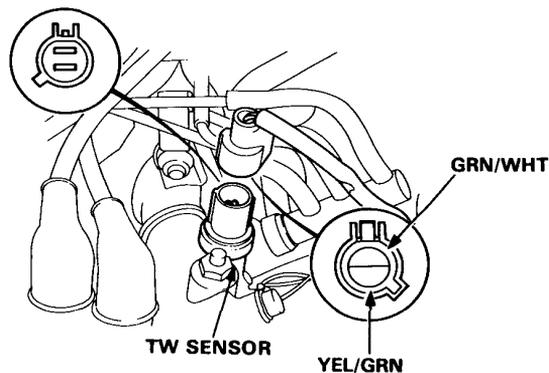
Disconnect the 2P connector on the TW sensor.

Measure resistance between the 2 terminals on the TW sensor.

Is there 200—400Ω ?

Measure voltage between YEL/GRN (+) terminal and body ground.

Is there approx. 5V ?
