2018 Accord: Body Repair Information

DISCLAIMER: This publication contains a summary of new body and vehicle technology that may affect collision and other body repairs. Always refer to the appropriate service and body repair manuals (BRM) for complete repair information. A subscription may be purchased at: techinfo.honda.com

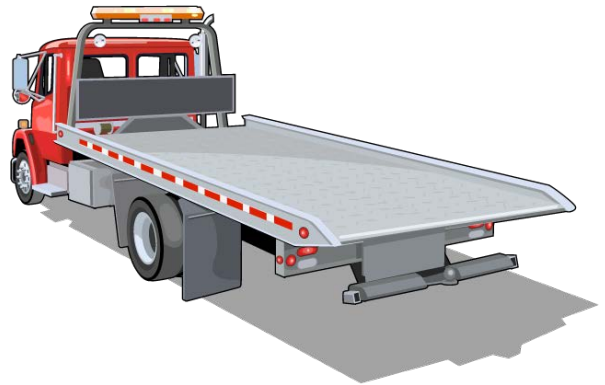
- Lift or jack only at the points specified in the owner’s guide to avoid damaging the vehicle.
- Do not lift or tow this vehicle by its bumpers, or serious damage will result.

For more information, refer to “Lift and Support Points” in the service or body repair manual.

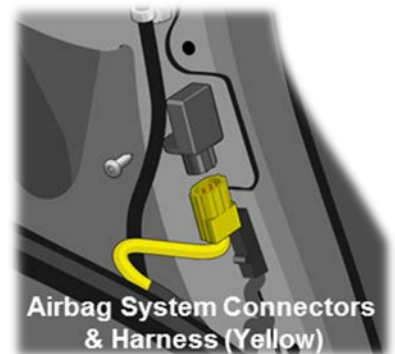
- For easier identification, electrical connectors that contain only airbag system wiring are yellow in color.
- Many harnesses that contain primarily airbag wiring are also wrapped in yellow tape.
- Airbag system wiring that runs in a common harness, such as a floor harness, is generally not marked.
- **Never** attempt to modify, splice, or repair airbag system wiring. If any part of the airbag system wiring is damaged, replace the affected wiring harness(es).

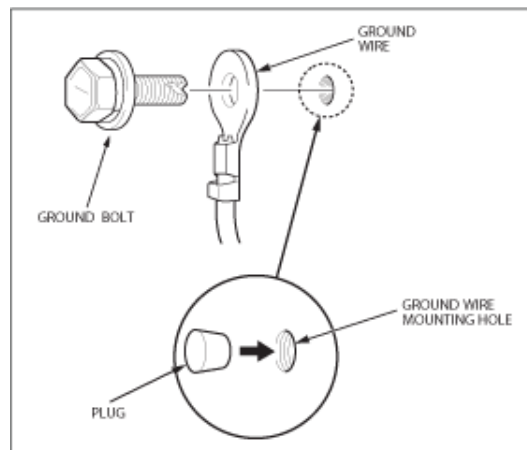
- Painting over electrical ground locations may cause electrical systems, such as vehicle stability assist (VSA), to malfunction and set DTCs that may be difficult to diagnose.
- Protect the ground wire and the ground wire mounting hole threads with a bolt or silicone plug when priming or painting.
