Shift Indicator Panel

Adjustment

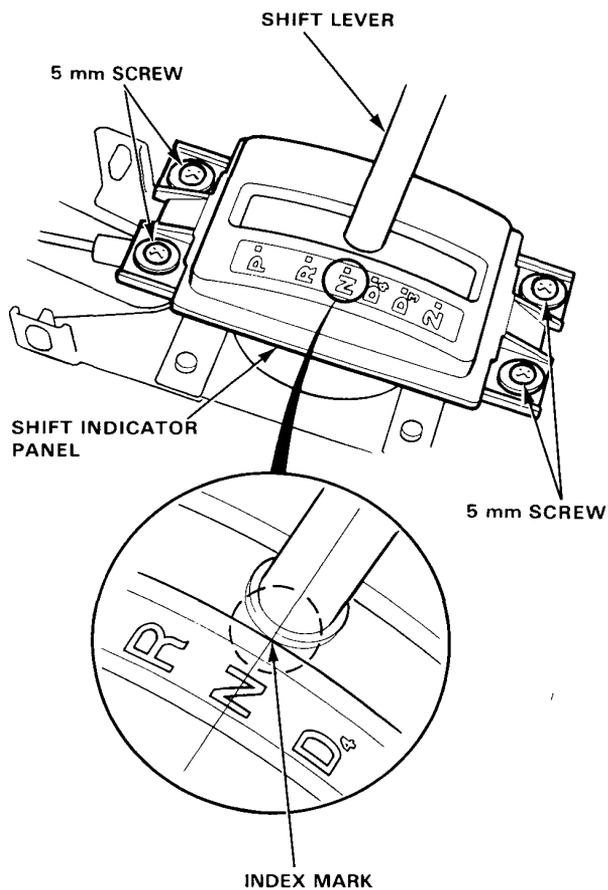
1. Check that the index mark of the indicator aligns with the N mark of the shift indicator panel with the transmission in NEUTRAL.
2. If not aligned, remove the panel mounting screws and adjust by moving panel.

NOTE: Whenever escutcheon is removed for indicator bulb replacement etc., reinstall the panel as described above.
